Virginia State University
MS-4 Permit: VAR040119
July 1, 2018 - June 30, 2019 Annual Report

Prepared for
Virginia State University
Capital Outlay & Facilities Management
PO Box 9414
Virginia State University, VA 23806

Prepared by: Timmons Group
1001 Boulders Parkway, Suite 300
Richmond, VA 23225
(804) 200-6500

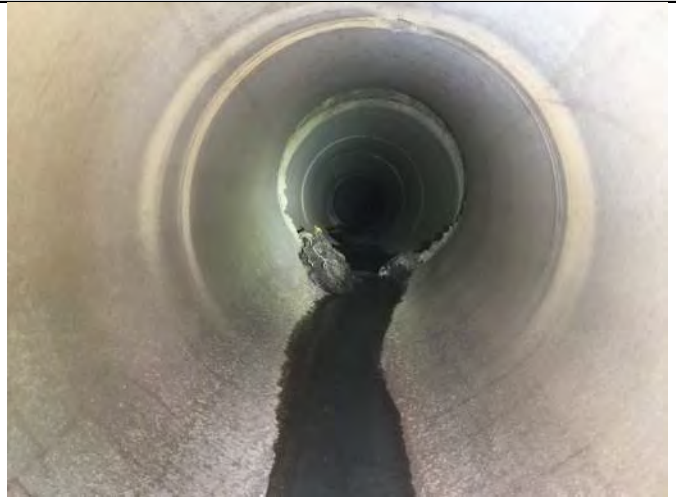
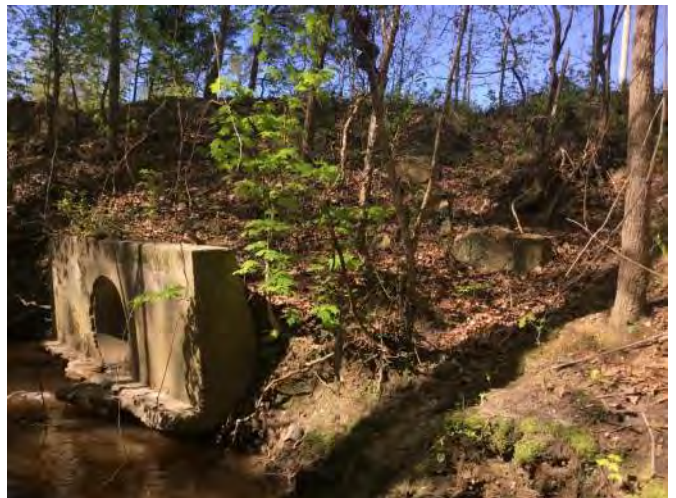
Outfall ID: 1	Date: 4/17/2019	Time: 10:06	Inspector: MSW
---------------	-----------------	-------------	----------------

Indicator	Present?	Description	Relative Severity Index (1-3)
Odor	No	NA	NA
Turbidity	No	See Severity Index	NA
Floatables	No	NA	NA
Deposits/Stains	No	NA	NA
Poor Pool Quality	No	NA	NA
Pipe Benthic Growth	Yes	Green	1

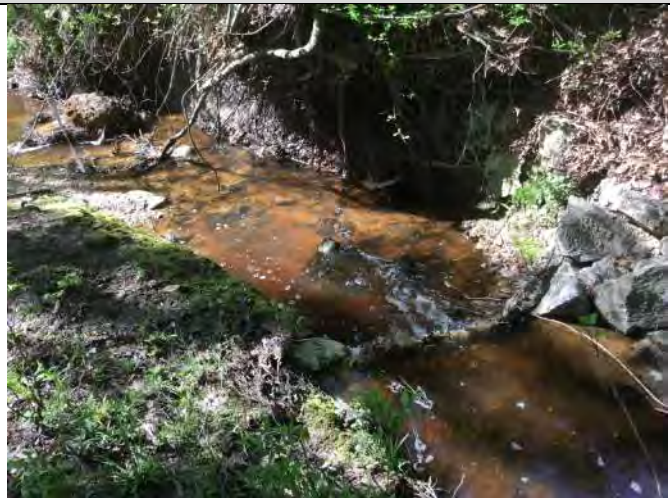
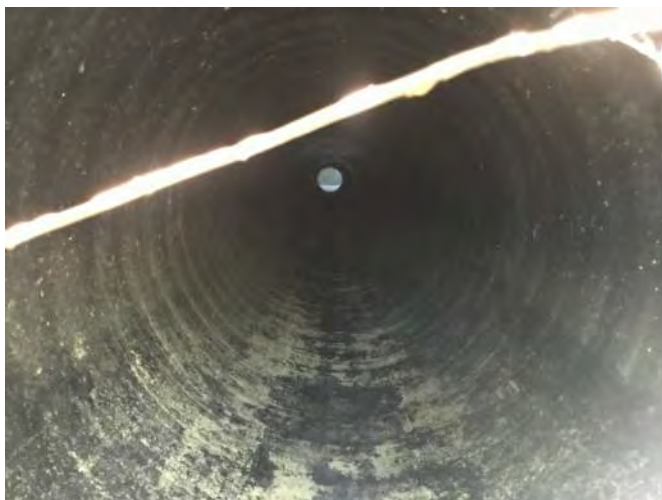
Outfall ID: 2	Date: 4/17/2019	Time: 10:14am	Inspector: MSW
---------------	-----------------	---------------	----------------

Indicator	Present?	Description	Relative Severity Index (1-3)
Odor	No	NA	NA
Turbidity	No	See Severity Index	NA
Floatables	No	NA	NA
Deposits/Stains	No	NA	NA
Poor Pool Quality	Yes	Other: Trash	1
Pipe Benthic Growth	No	NA	NA

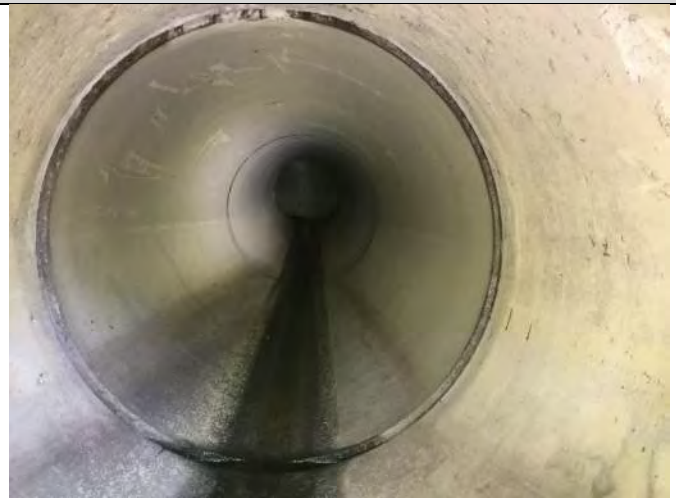
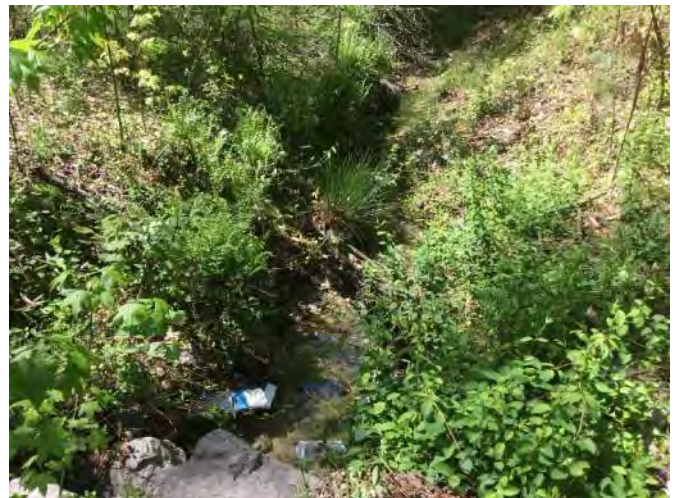
Outfall ID: 9	Date: 4/17/2019	Time: 12:40pm	Inspector: MSW
---------------	-----------------	---------------	----------------

Indicator	Present?	Description	Relative Severity Index (1-3)
Odor	Yes	Other: Musty	2
Turbidity	No	See Severity Index	NA
Floatables	No	NA	NA
Deposits/Stains	No	NA	NA
Poor Pool Quality	No	NA	NA
Pipe Benthic Growth	Yes	Other: Black	2

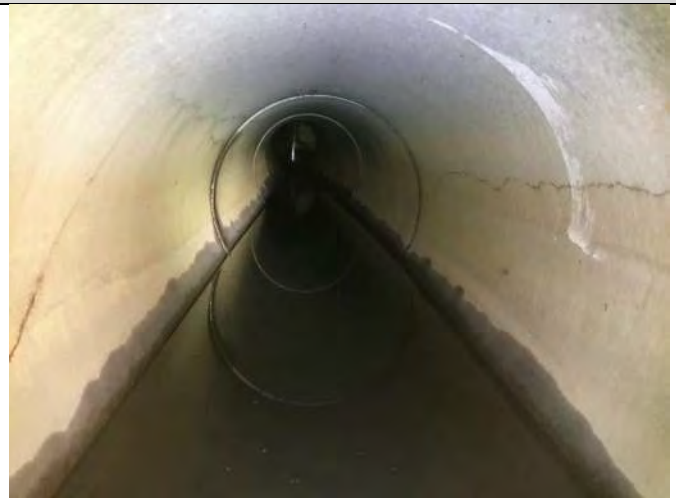
Outfall ID: 11	Date: 4/17/2019	Time: 1:08pm	Inspector: MSW
----------------	-----------------	--------------	----------------

Indicator	Present?	Description	Relative Severity Index (1-3)
Odor	Yes	Other: Swampy	2
Turbidity	No	See Severity Index	NA
Floatables	No	NA	NA
Deposits/Stains	No	NA	NA
Poor Pool Quality	No	NA	NA
Pipe Benthic Growth	No	NA	NA

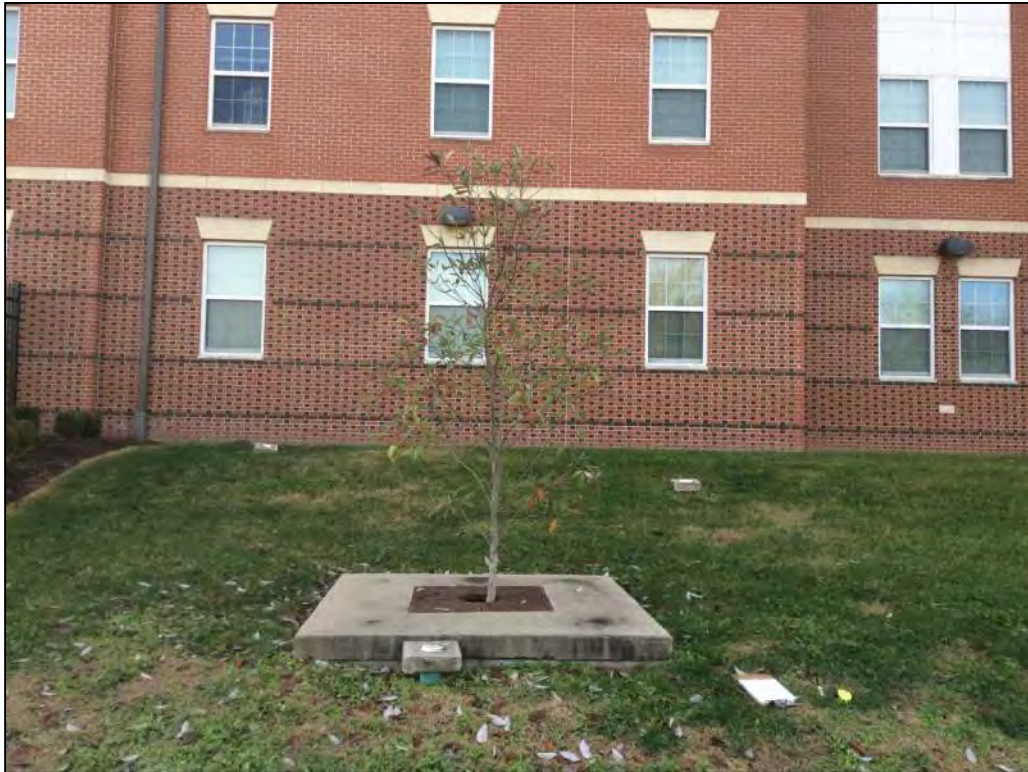
BMP 1-6, 16-21: Roof Inlet Filterra (Typ.)

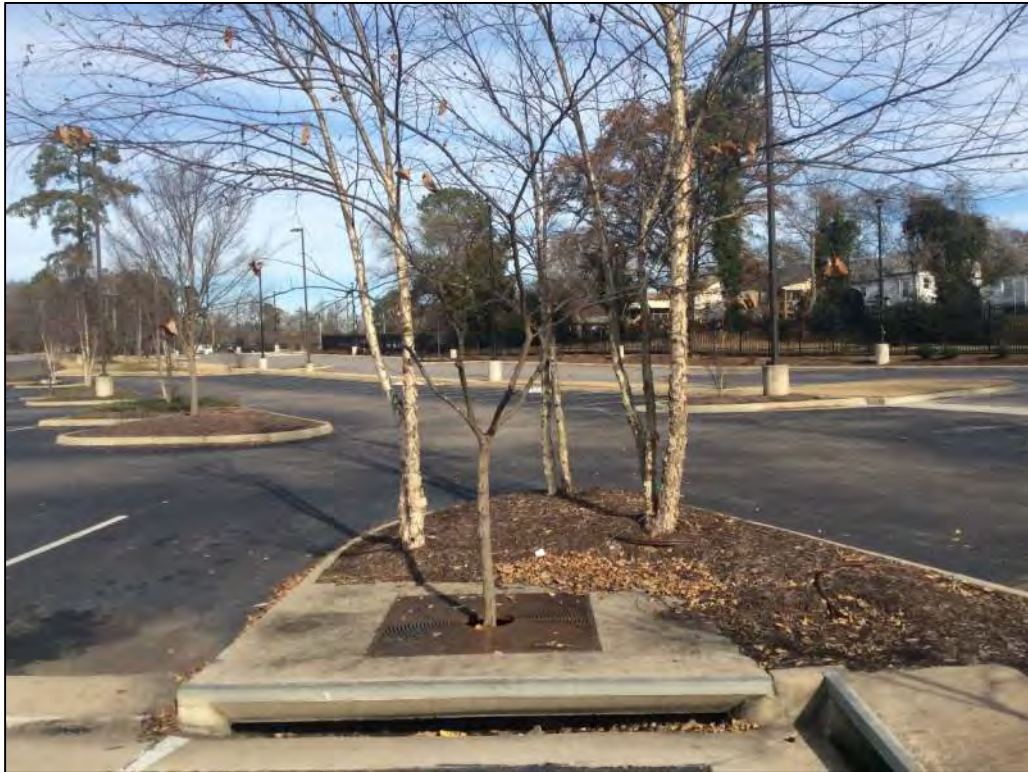
BMP 7-13, 41-44: Curb Inlet Filterra (Typ.)

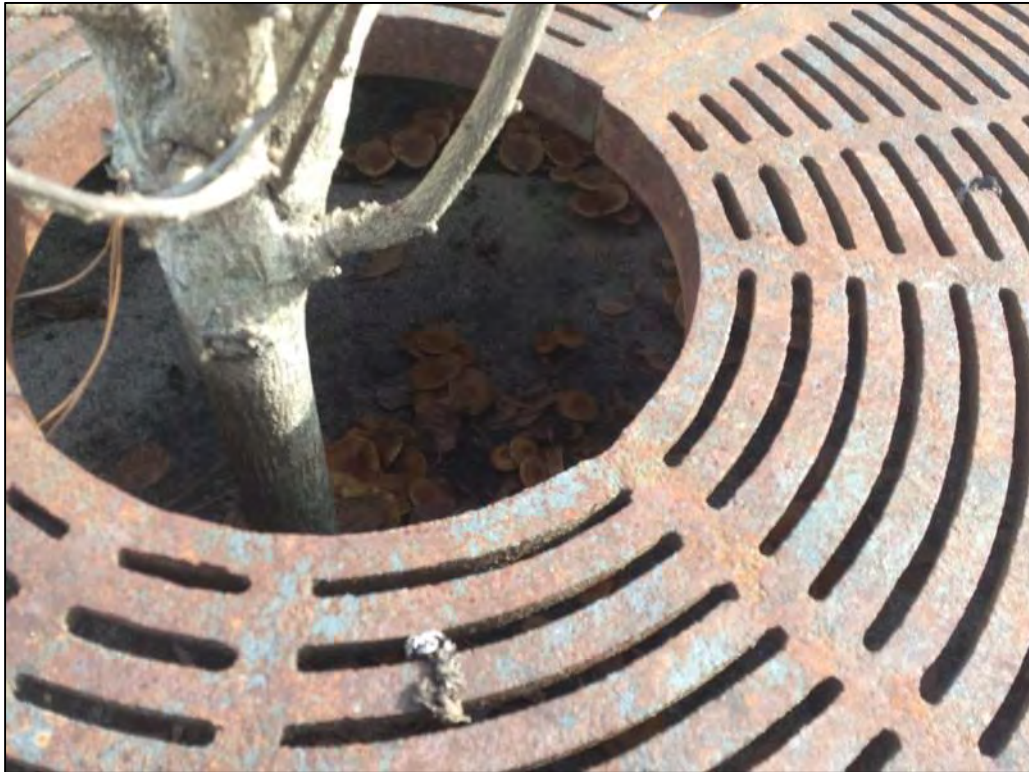
Silt/Clay within Filterra (Typ.)

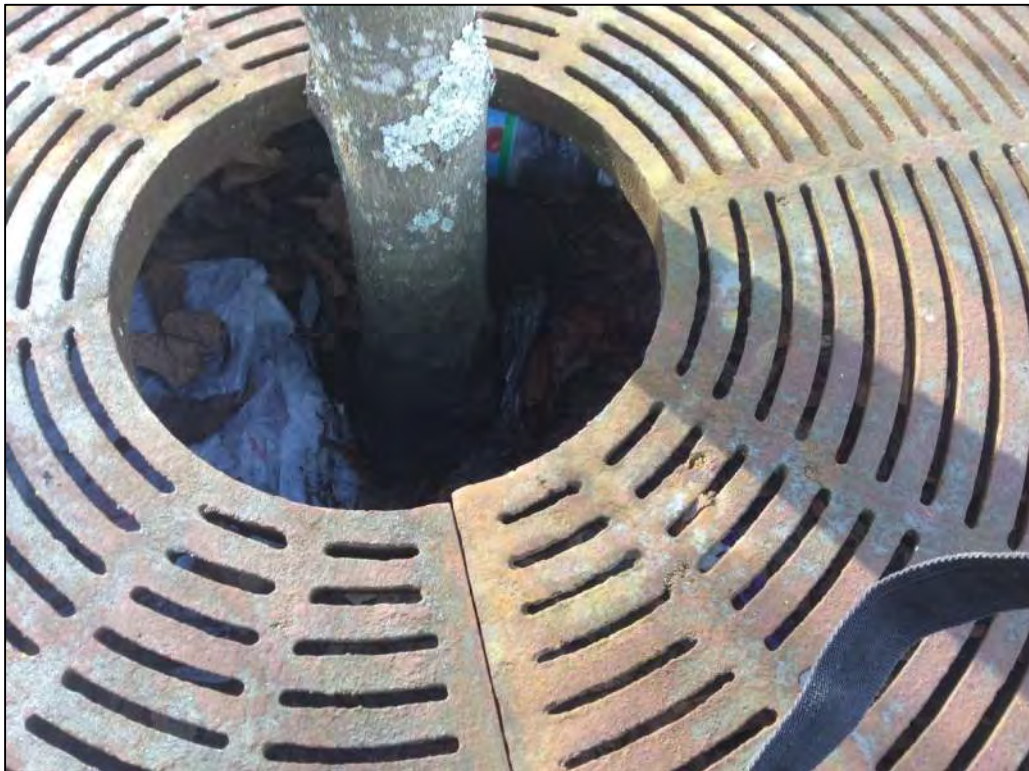
Cups/Bags/Trash within Filterra (Typ.)

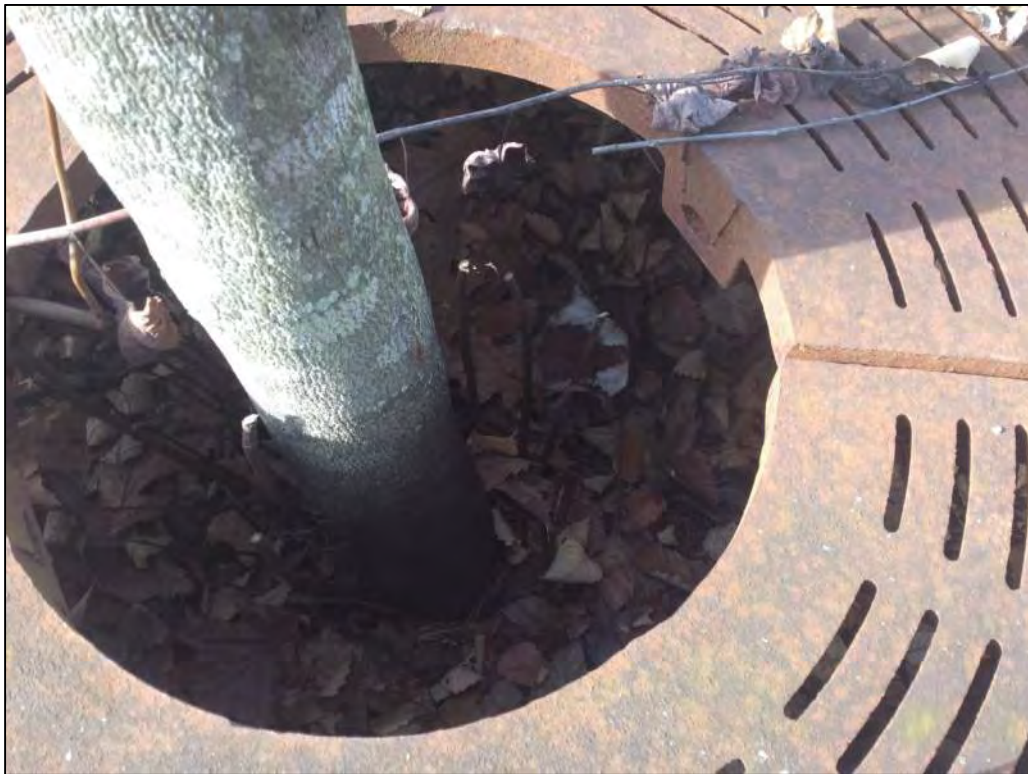
Leaves within Filterra (Typ.)

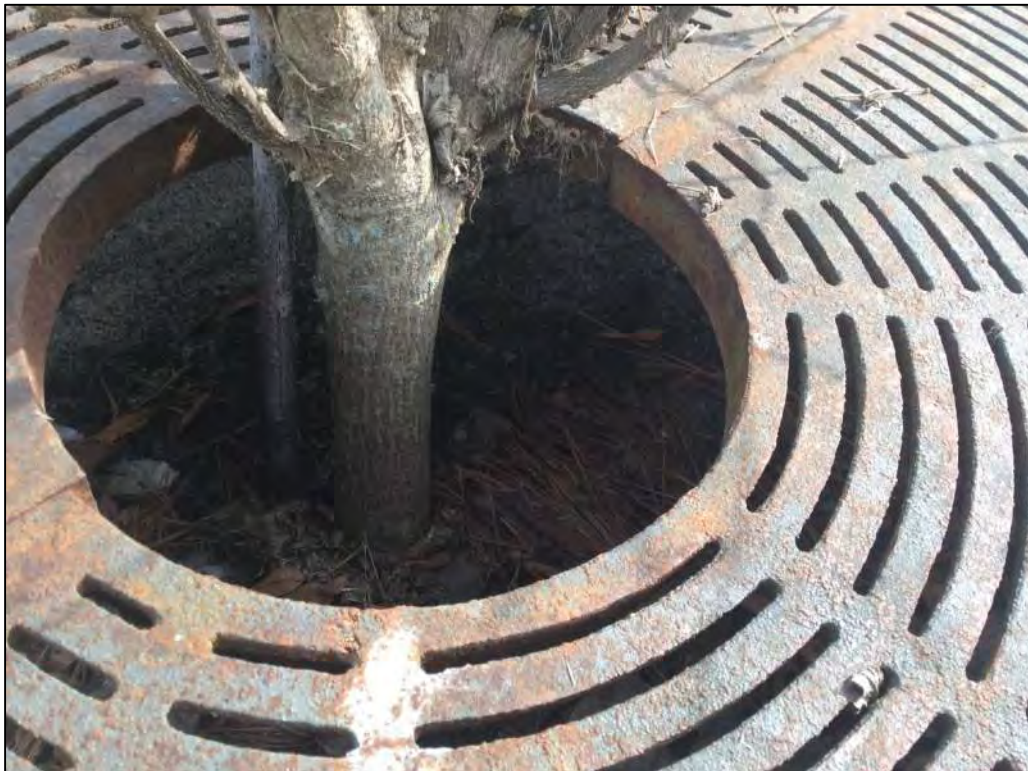
Netting in Need of Replacement (Typ.)
