Virginia State University
MS-4 Permit: VAR040119
July 1, 2014 - June 30, 2015 Annual Report

Prepared for
Virginia State University
Capital Outlay & Facilities Management
PO Box 9414
Virginia State University, VA 23806

October 1, 2015

Prepared by: Timmons Group
1001 Boulders Parkway, Suite 300
Richmond, VA 23225
(804) 200-6500

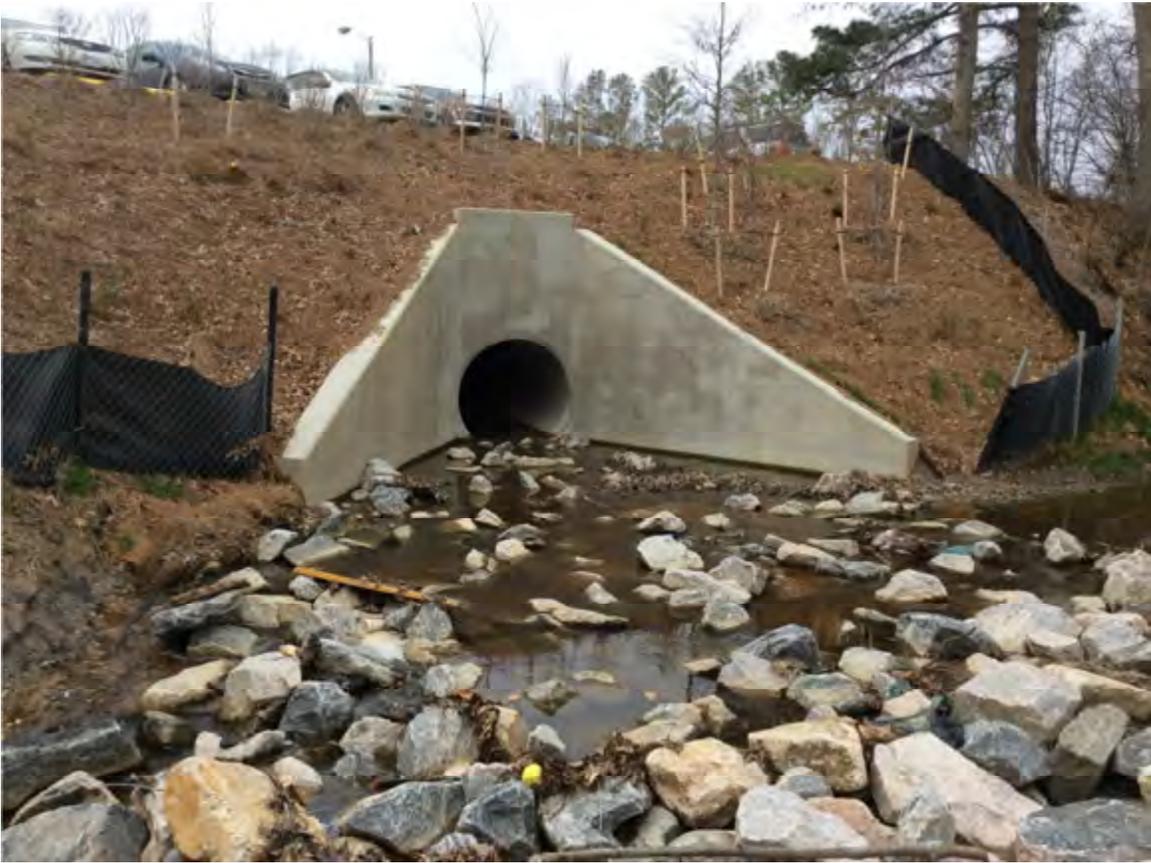
Outfall 3 – #316

Deposits/Stains	<input checked="" type="checkbox"/> Y/N	
Describe	<u>Sediment @ bottom</u>		
Vegetation Condition (Circle)	Excessive	Inhibited	
Describe	<u>None</u>		
Pipe Condition (Circle)	<input checked="" type="checkbox"/> Good	Fair	Poor
Describe

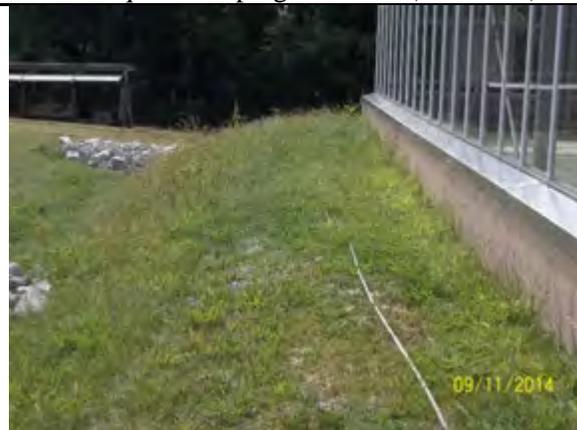
Fig. 3 – Recommend cutting tall grass around the greenhouse addition (view-south).

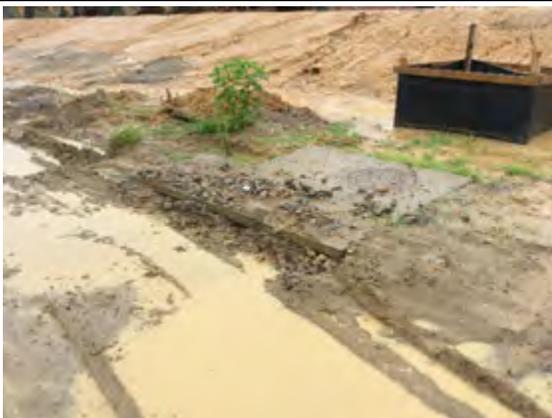
Inlet protection needs clean out and retrenched

Clean out and repair inlet protection

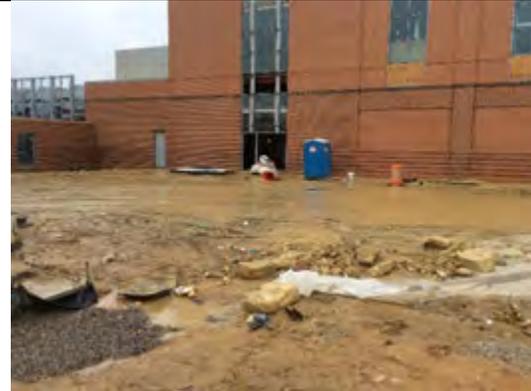
Trash and debris (concrete supplies) must be disposed of properly
