Virginia State University
MS-4 Permit: VAR040119
July 1, 2018 - June 30, 2019 Annual Report

Prepared for
Virginia State University
Capital Outlay & Facilities Management
PO Box 9414
Virginia State University, VA 23806

Prepared by: Timmons Group
1001 Boulders Parkway, Suite 300
Richmond, VA 23225
(804) 200-6500

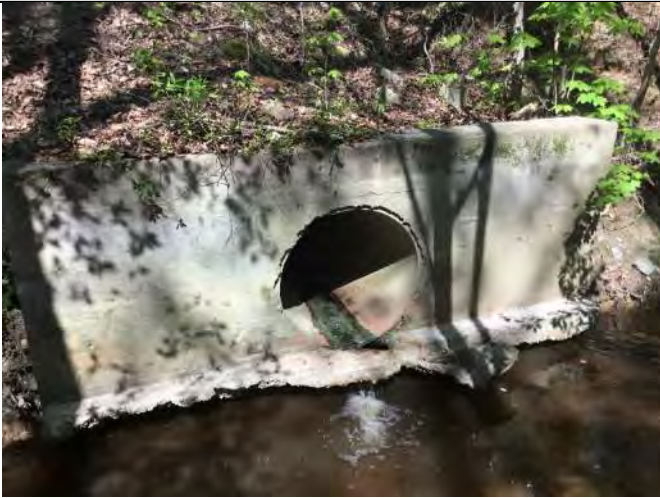
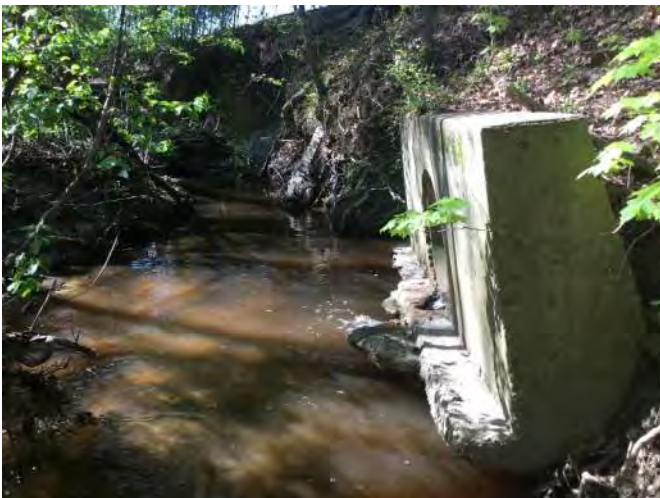
Outfall ID: 1	Date: 4/17/2019	Time: 10:06	Inspector: MSW
---------------	-----------------	-------------	----------------

Indicator	Present?	Description	Relative Severity Index (1-3)
Odor	No	NA	NA
Turbidity	No	See Severity Index	NA
Floatables	No	NA	NA
Deposits/Stains	No	NA	NA
Poor Pool Quality	No	NA	NA
Pipe Benthic Growth	Yes	Green	1

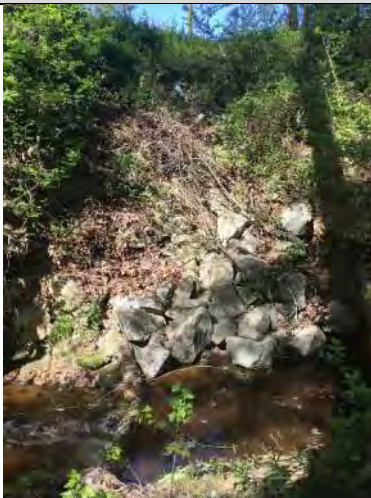
Outfall ID: 2	Date: 4/17/2019	Time: 10:14am	Inspector: MSW
---------------	-----------------	---------------	----------------

Indicator	Present?	Description	Relative Severity Index (1-3)
Odor	No	NA	NA
Turbidity	No	See Severity Index	NA
Floatables	No	NA	NA
Deposits/Stains	No	NA	NA
Poor Pool Quality	Yes	Other: Trash	1
Pipe Benthic Growth	No	NA	NA

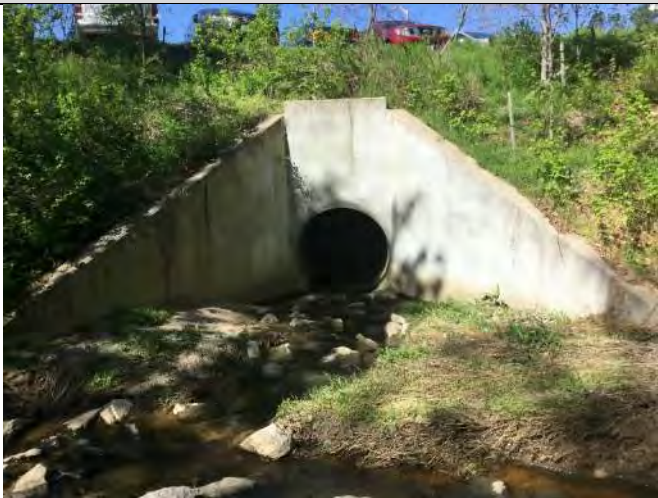
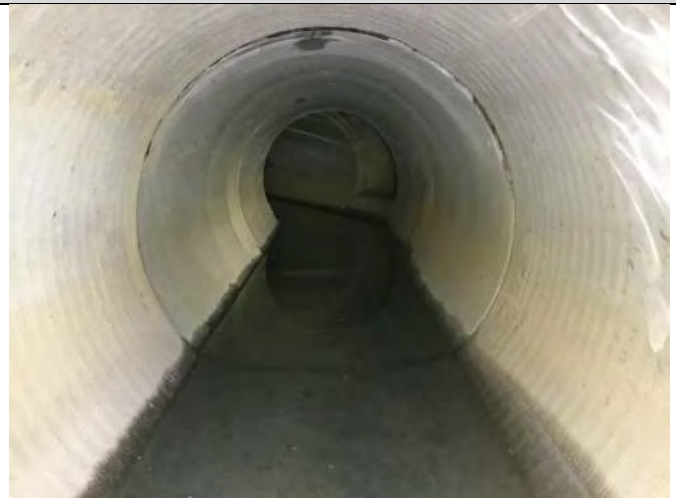
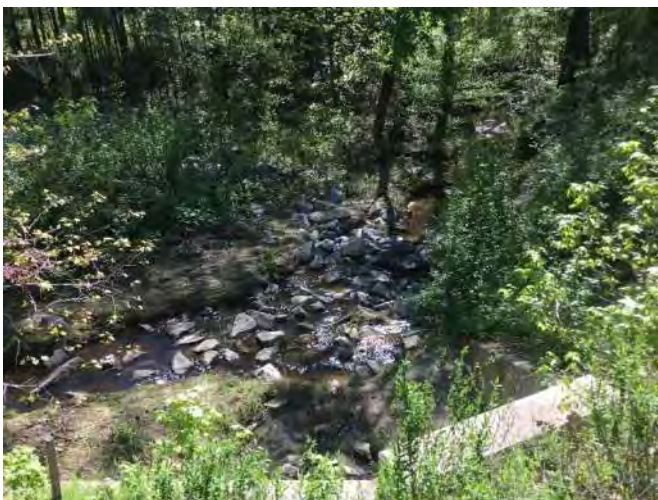
Outfall ID: 3	Date: 4/17/2019	Time: 10:21am	Inspector: MSW
---------------	-----------------	---------------	----------------

Indicator	Present?	Description	Relative Severity Index (1-3)
Odor	No	NA	NA
Turbidity	No	See Severity Index	NA
Floatables	No	NA	NA
Deposits/Stains	No	NA	NA
Poor Pool Quality	No	NA	NA
Pipe Benthic Growth	No	NA	NA

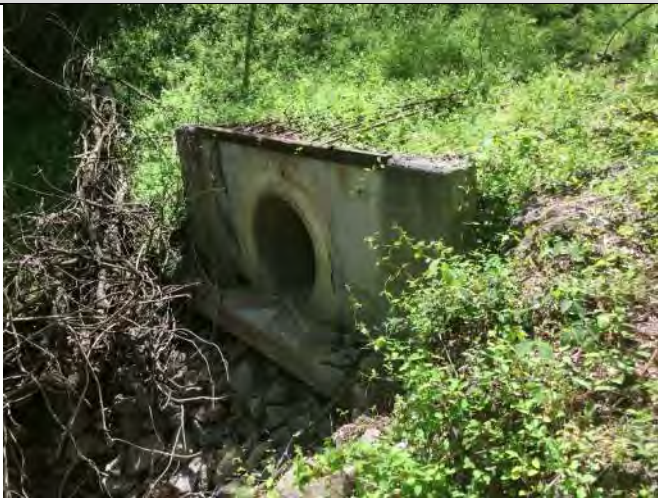
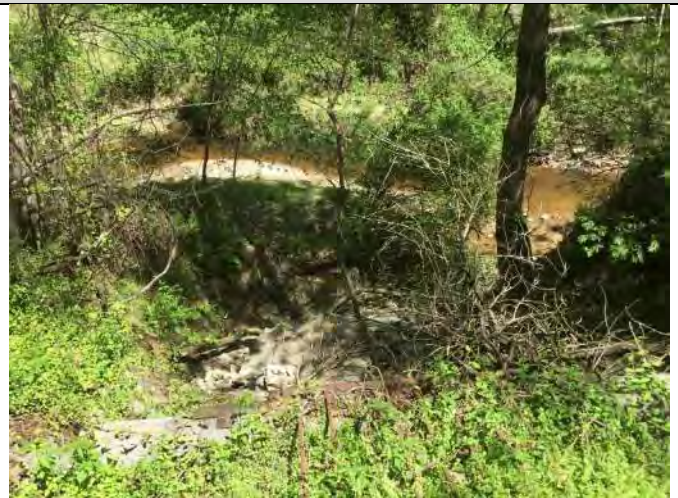
Indicator	Present?	Description	Relative Severity Index (1-3)
Odor	Yes	Other: Swampy	2
Turbidity	No	See Severity Index	NA
Floatables	No	NA	NA
Deposits/Stains	No	NA	NA
Poor Pool Quality	No	NA	NA
Pipe Benthic Growth	No	NA	NA

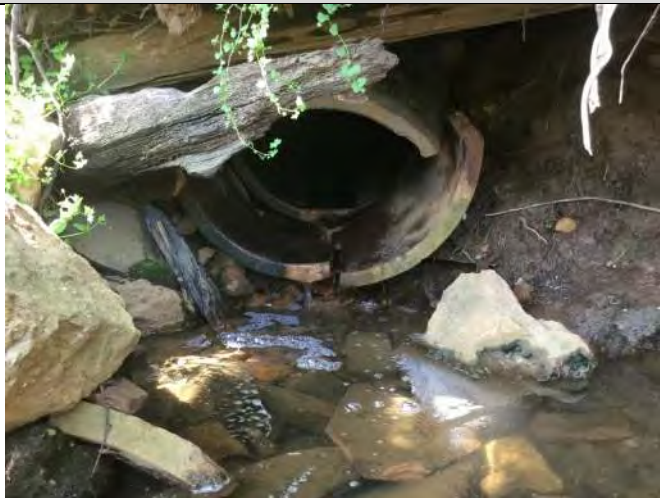
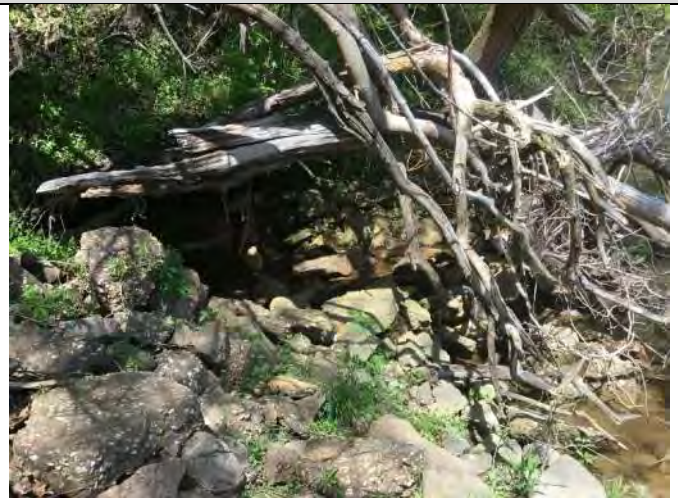
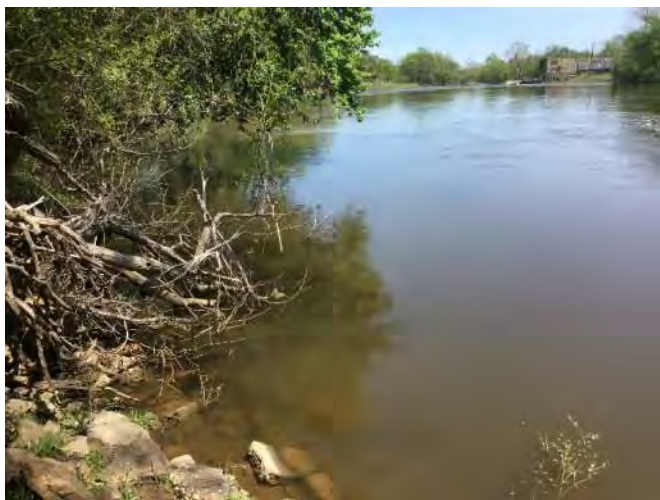
Outfall ID: 18	Date: 4/17/2019	Time: 2:06pm	Inspector: MSW
----------------	-----------------	--------------	----------------

Indicator	Present?	Description	Relative Severity Index (1-3)
Odor	Yes	Other, Sewage: Skunky	1
Turbidity	No	See Severity Index	NA
Floatables	Yes	Other: Scum	1
Deposits/Stains	No	NA	NA
Poor Pool Quality	Yes	Odors, Floatables	2
Pipe Benthic Growth	No	NA	NA

Notes:
 A potential sewage odor was detected during the inspection. A follow-up inspection was conducted and the next upstream manhole was investigated. No sewage odor was detected at the next upstream manhole and it was determined that the original outfall odor was due to environmental conditions at the time of inspection.

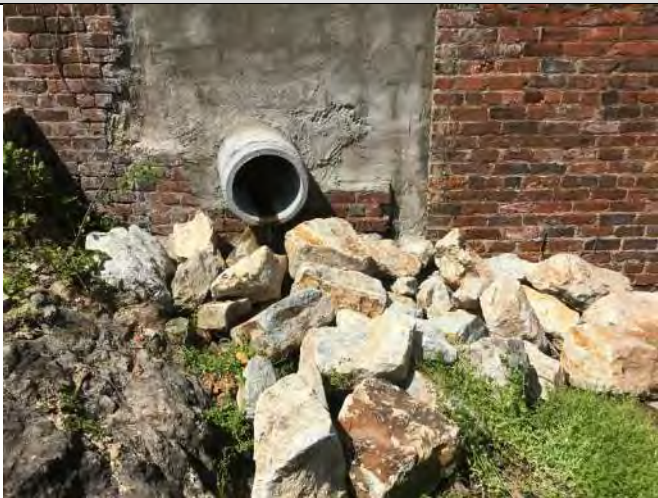
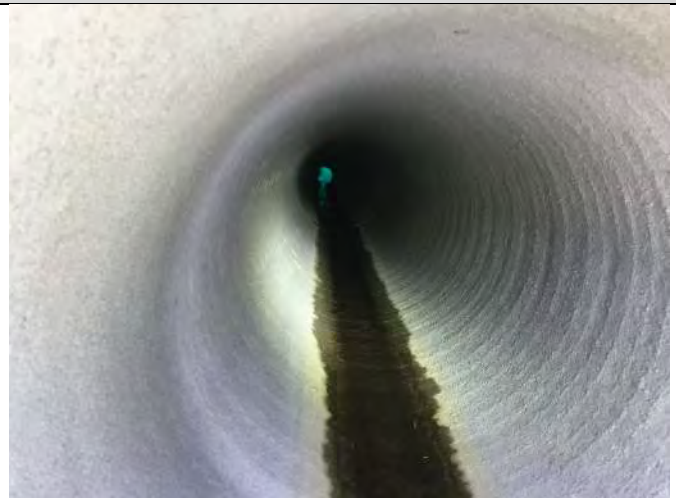
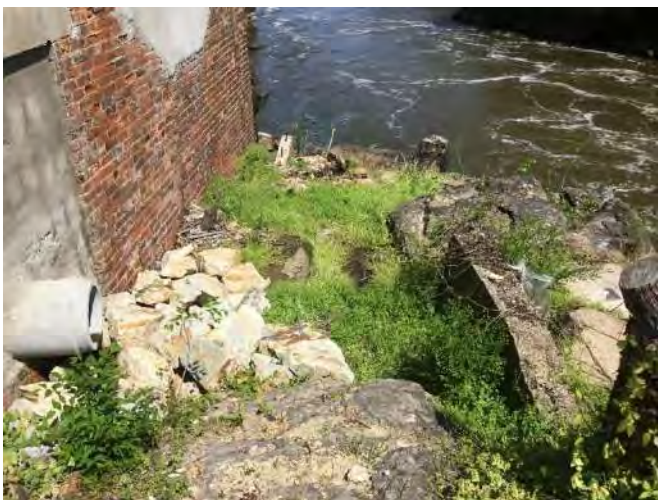
Outfall ID: New	Date: 4/17/2019	Time: 2:35pm	Inspector: MSW
-----------------	-----------------	--------------	----------------

Indicator	Present?	Description	Relative Severity Index (1-3)
Odor	No	NA	NA
Turbidity	No	See Severity Index	NA
Floatables	No	NA	NA
Deposits/Stains	No	NA	NA
Poor Pool Quality	No	NA	NA
Pipe Benthic Growth	Yes	Green	1
