Virginia State University
MS-4 Permit: VAR040119
July 1, 2014 - June 30, 2015 Annual Report

Prepared for
Virginia State University
Capital Outlay & Facilities Management
PO Box 9414
Virginia State University, VA 23806

October 1, 2015

Prepared by: Timmons Group
1001 Boulders Parkway, Suite 300
Richmond, VA 23225
(804) 200-6500

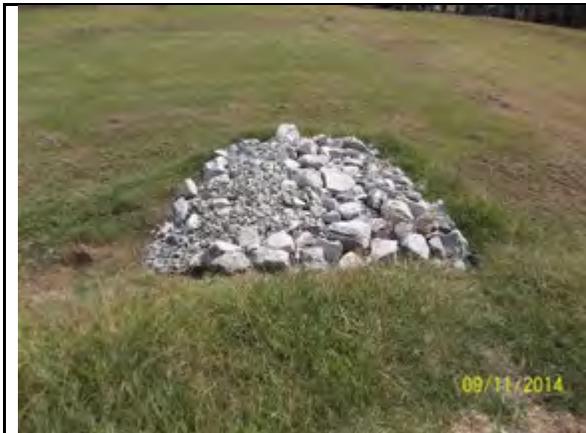
Fig. 1 – Check dam along east side of building that requires shaping revisions (view-east).

Item#	State/Local Regulation(1)	Violation		Description and Location of Problem/Violation(2), Required or Recommended Corrective Actions, and Other Comments/Notes
		Initial	Repeat	
1	Spec 3.05		X	Add silt fence where excavation work is proceeding. Fig 1 thru Fig 4
2	Spec 3.07		X	Complete the storm drain inlet protection. Silt fence was installed, sediment filter shall be added Fig 5
3	MS17		X	Is the transport of soil and mud onto public roadways properly controlled? NO, there is soil on the asphalt and sidewalks. Fig 6 and Fig 7. Area was not cleaned
4				
5

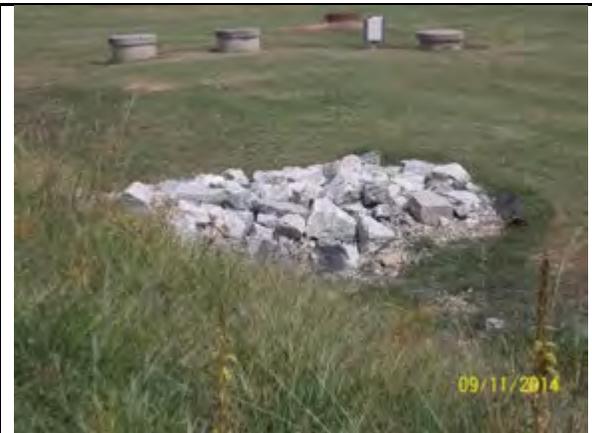
Fig. 2 – Check dam along east side of building that requires shaping revisions (view-east).

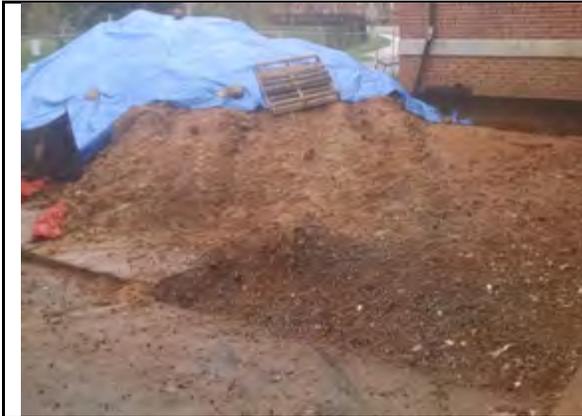
Fig 1 – Spec 3.05 West side of building

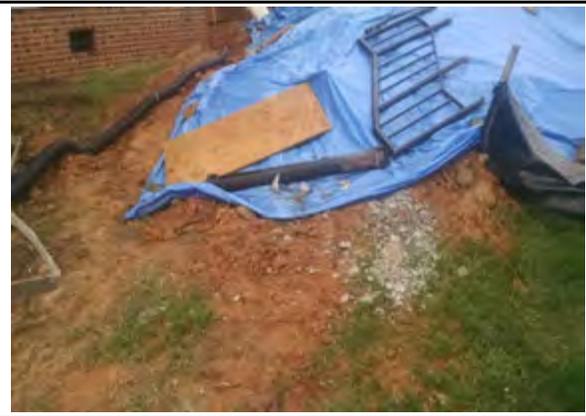
Fig 2 – Spec 3.05 West side of building

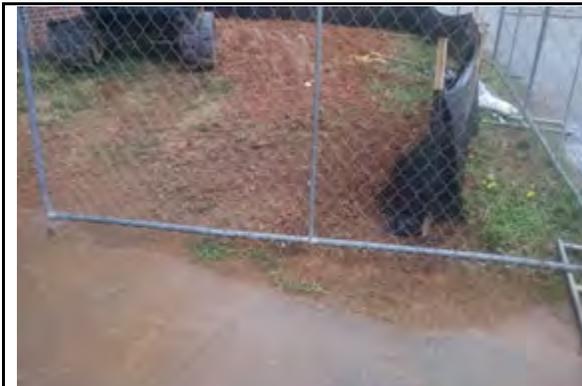
Fig 3 – Spec 3.05 East side of building

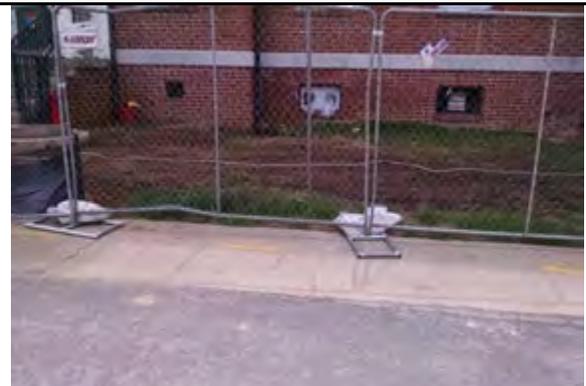
Fig 4 – Spec 3.05 North side of building.

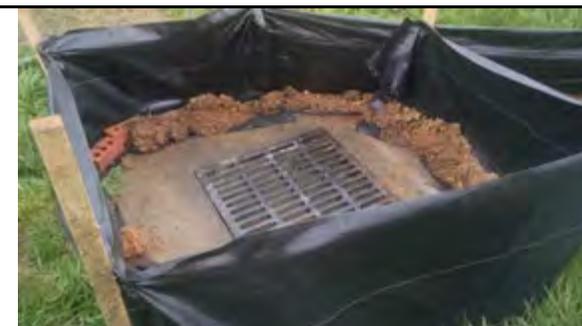
Fig 5 Spec 3.07 West side of building

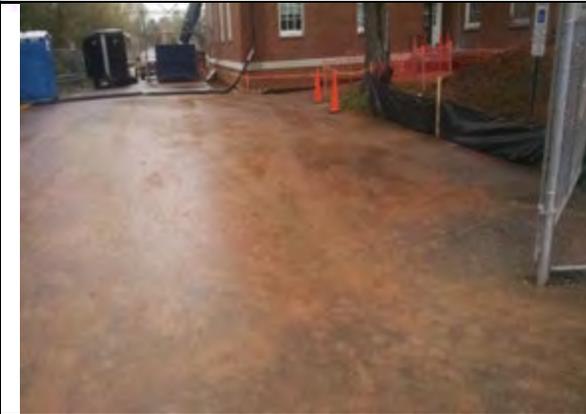
Fig 6 MS17 East side of building

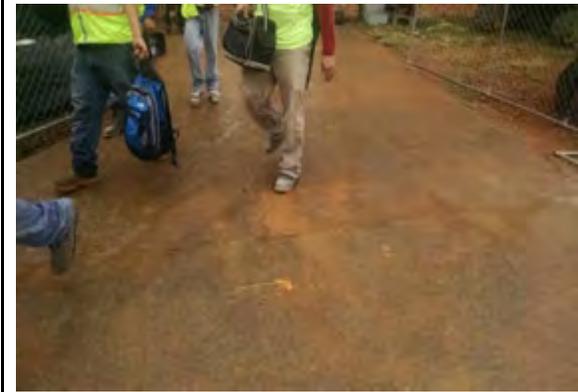
Fig 7 MS17 East side of building

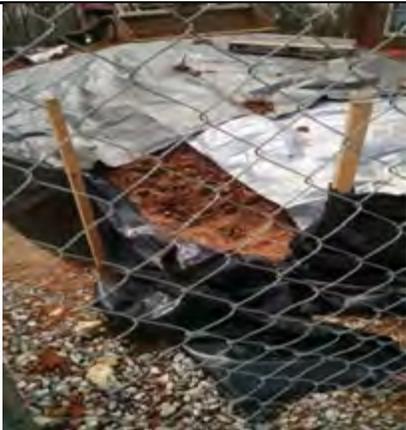
CORRECTED: Fig 1 – Spec 3.05.A-East side of building

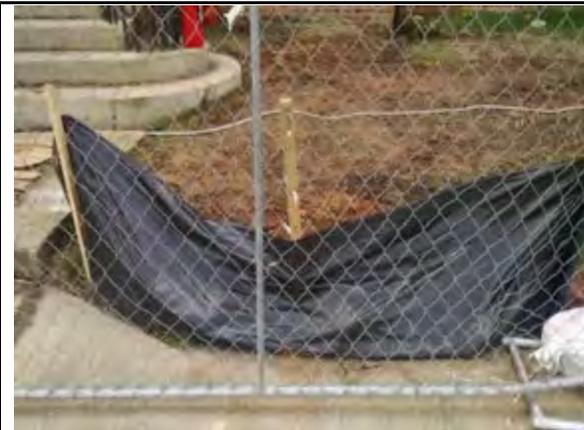
CORRECTED: Fig 2 – Spec 3.05.A-North side of building

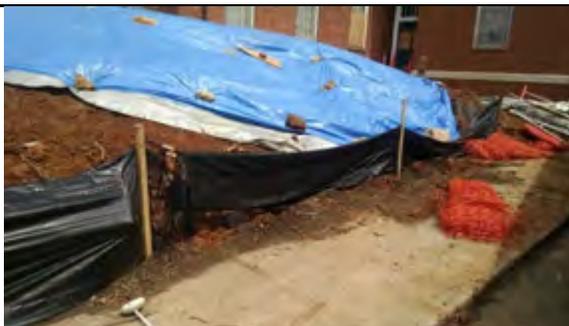
CORRECTED: Fig 3 – Spec 3.05.A-South side of building.

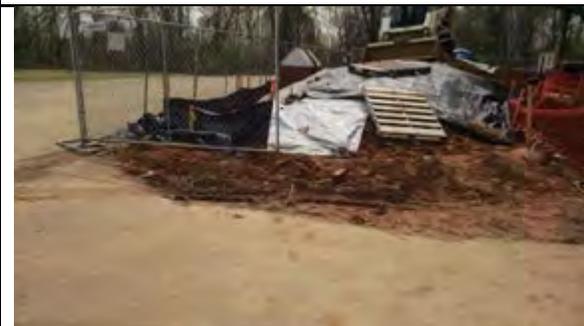
CORRECTED: Fig 4 – Spec 3.05.B-East side of building.

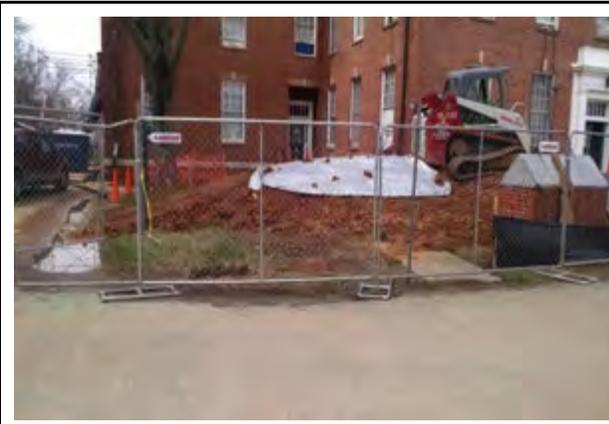
CORRECTED: Fig 5 – Spec 3.05.B-East side of building

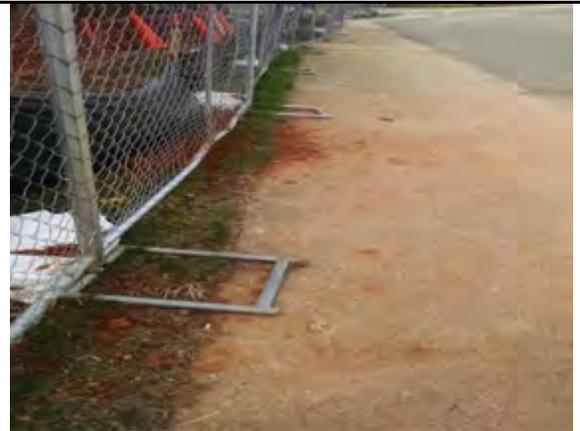
CORRECTED Fig 8 – MS17-North side of building

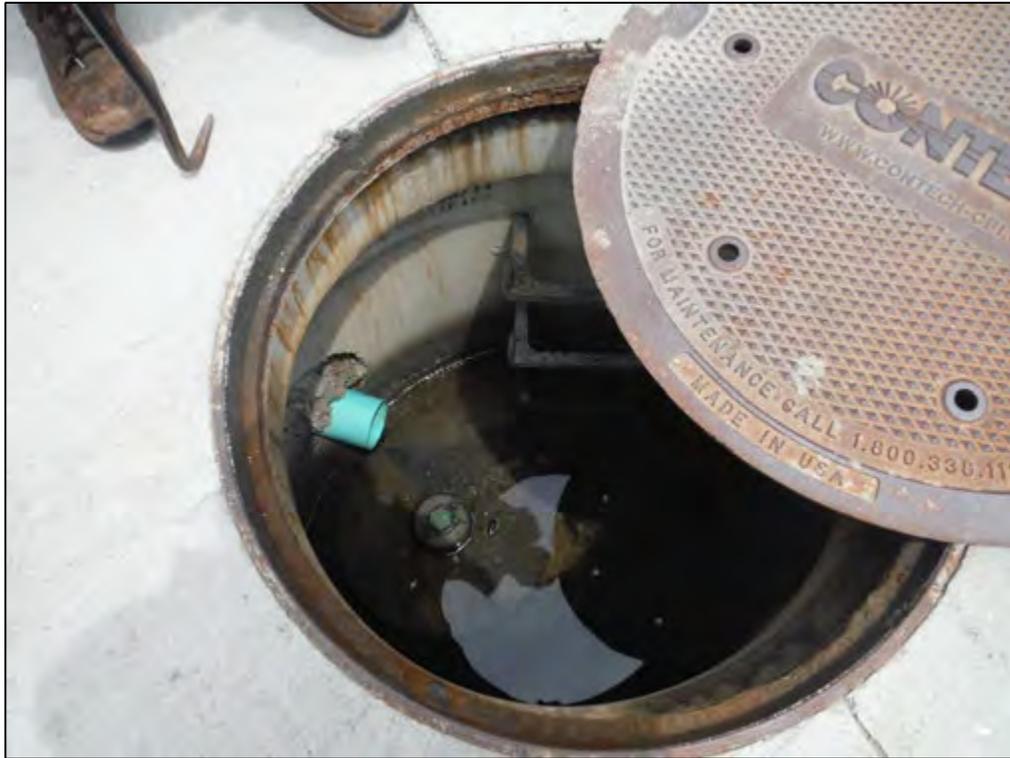
BMP #22: Howard Quad II Stormfilter

I. Below Ground Vault						
Sediment accumulation top of cartridge		✓	Sediment depth exceeds 0.25 inches		✓	
Sediment accumulation in vault	✓		Sediment depth exceeds 4 inches in the first chamber	✓		<i>70.7' sediment</i>
Submerged cartridges	✓		More than 4" of static water in the cartridge bay 24 hours after last rainfall event	✓		<i>> 1' water</i>
Trash/debris accumulation		✓	Trash and debris accumulated on compost filter bed		✓	
Sediment in drain pipes or cleanouts		✓	Drain pipes and/or clean outs are full of sediment and/or debris		✓	
Damaged pipes		✓	Any part of any pipe crushed or damaged due to corrosion and/or settlement		✓	
Access cover damaged/not working		✓	Cover cannot be opened; one person cannot open the cover using normal lifting pressure; corrosion/deformation of cover		✓	
Vault structure includes cracks in wall or bottom; damage to the frame and/or top slab		✓	Cracks wider than 1/2 inch or evidence of soil particles entering the structure through cracks; determination that the vault is not structurally sound		✓

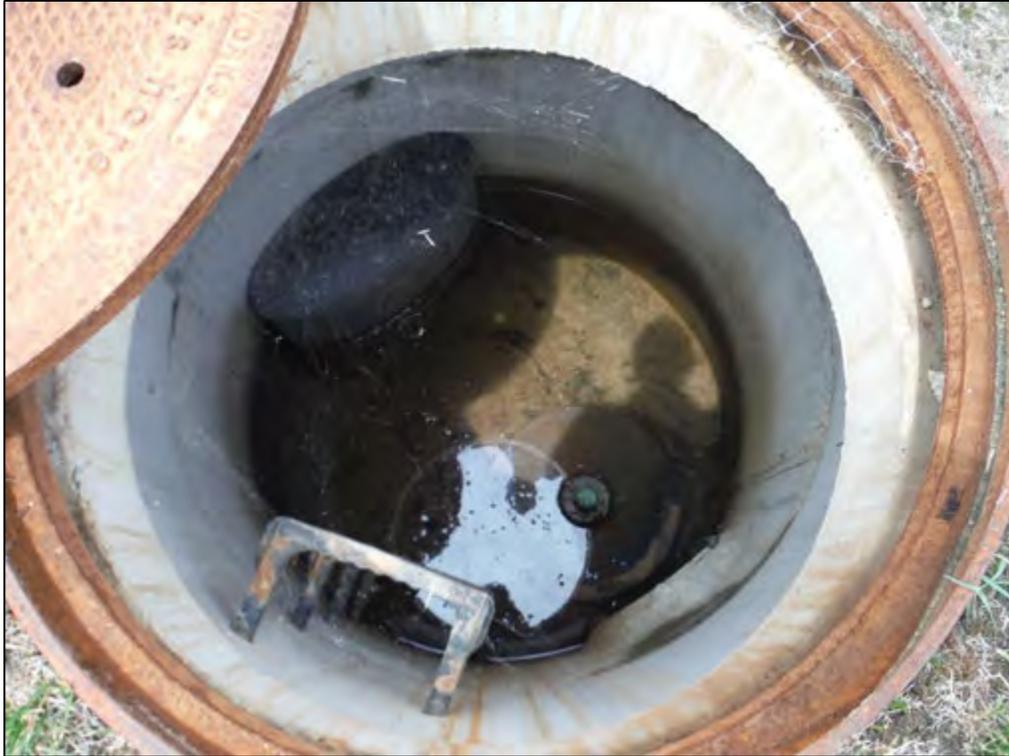
BMP #23: Howard Quad Courtyard Stormfilter

I. Below Ground Vault						
Sediment accumulation top of cartridge		✓	Sediment depth exceeds 0.25 inches		✓	
Sediment accumulation in vault	✓		Sediment depth exceeds 4 inches in the first chamber	✓		<i>> 0.5'</i>
Submerged cartridges	✓		More than 4" of static water in the cartridge bay 24 hours after last rainfall event	✓		<i>> 1'</i>
Trash/debris accumulation		✓	Trash and debris accumulated on compost filter bed		✓	
Sediment in drain pipes or cleanouts	✓		Drain pipes and/or clean outs are full of sediment and/or debris	✓		
Damaged pipes		✓	Any part of any pipe crushed or damaged due to corrosion and/or settlement		✓	
Access cover damaged/not working		✓	Cover cannot be opened; one person cannot open the cover using normal lifting pressure; corrosion/deformation of cover		✓	
Vault structure includes cracks in wall or bottom; damage to the frame and/or top slab		✓	Cracks wider than 1/8 inch or evidence of soil particles entering the structure through cracks; determination that the vault is not structurally sound		✓

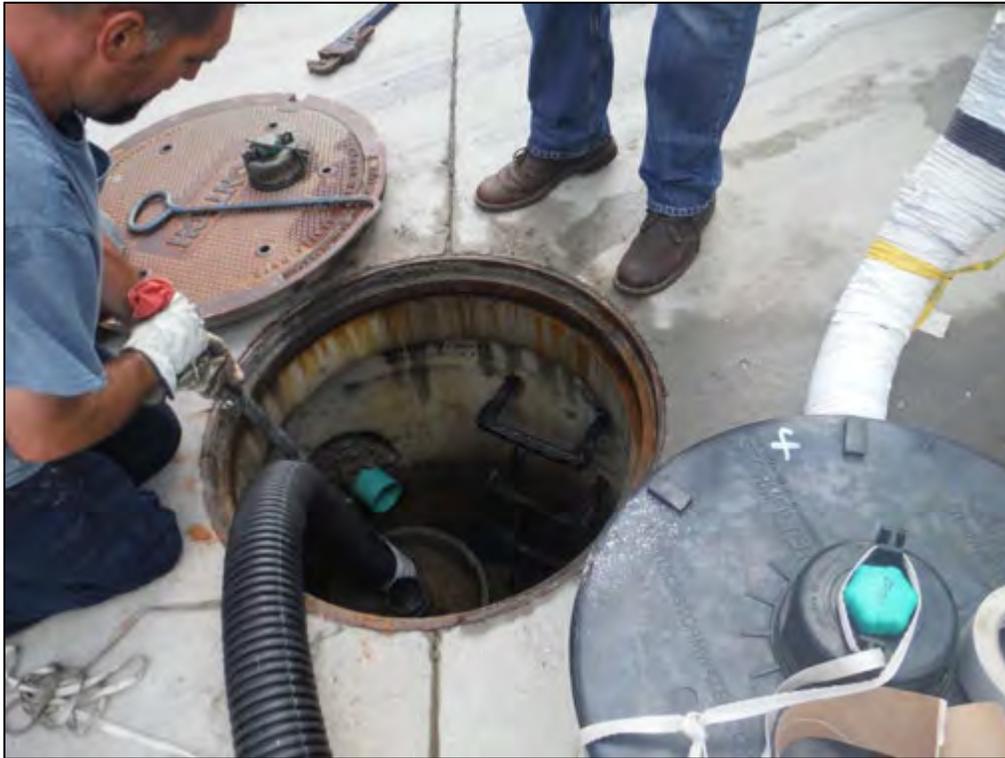
BMP #22: Howard Hall Quad II Courtyard (Contect Stormfilter 1)
Vacuming out clogged filter media

Atlas Industrial Services performed maintenance on two Stormfilters on July 17, 2015. For each storm filter, standing water and accumulated sediment was vacuumed out of the manhole. Then, the cover to each Stormfilter was removed and the clogged filter media was vacuumed out. Once the filter was cleaned out it, was removed from the manhole to be returned to the distributor for refurbishing. Any residual water and/or sediment still remaining in the manhole was then vacuumed out and a new Stormfilter with clean filter media was installed. The maintenance procedure for each Stormfilter was identical and the following photos show steps of the process.

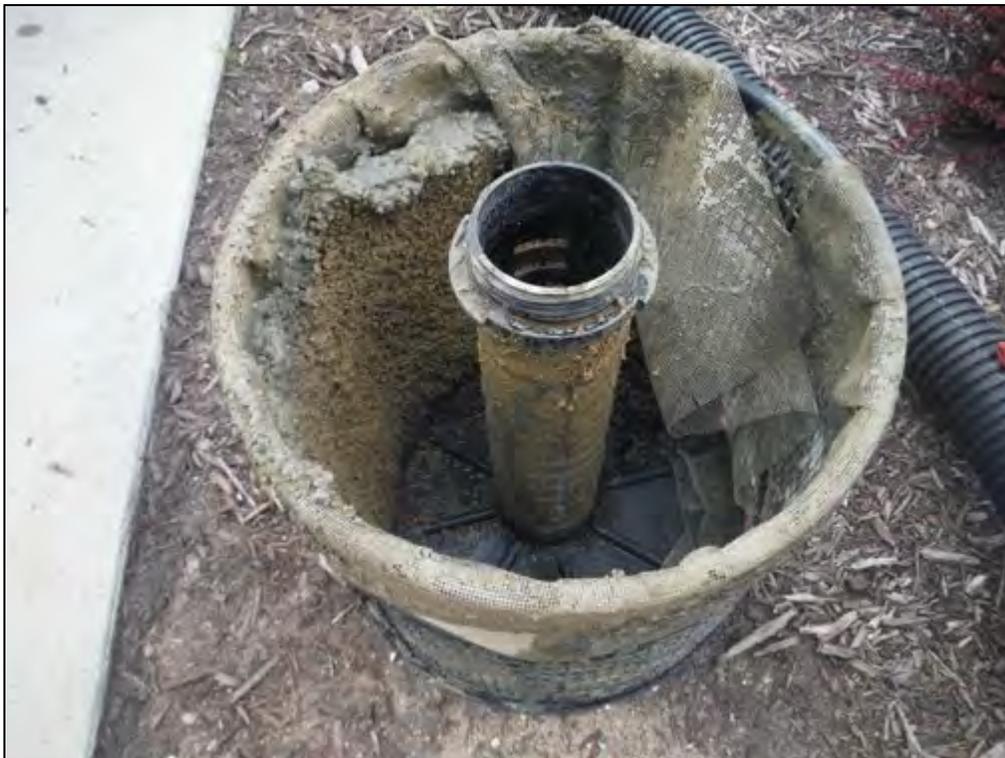
BMP #22: Howard Hall Quad II Courtyard (Contect Stormfilter 1)
Removed filter housing

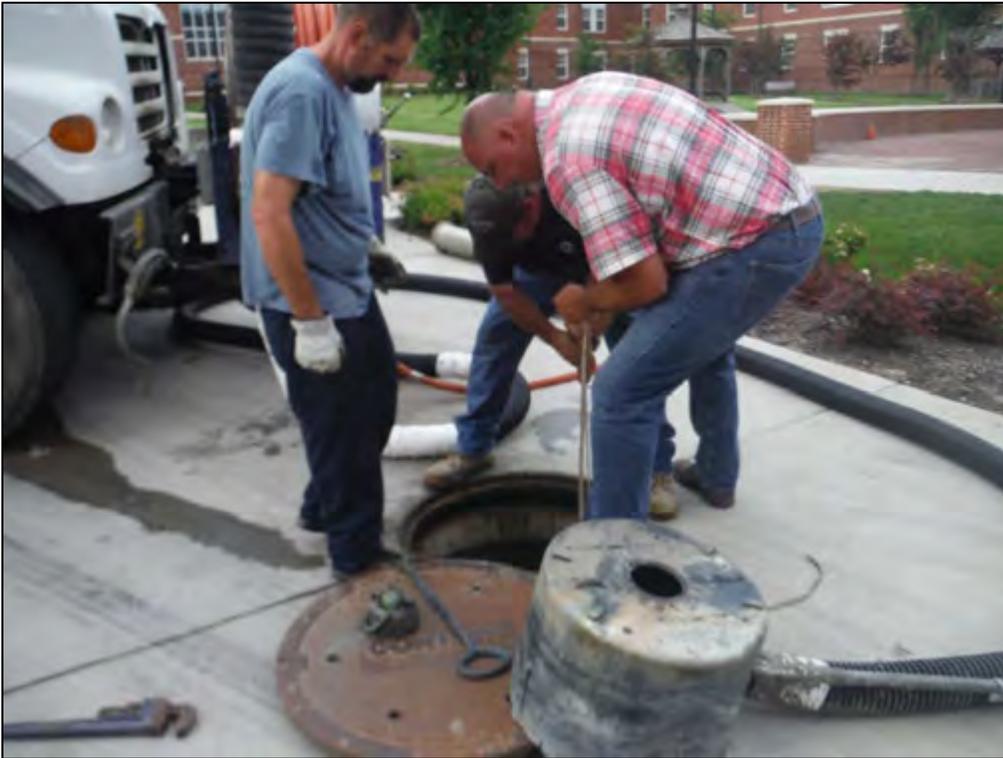
BMP #22: Howard Hall Quad II Courtyard (Contect Stormfilter 1)
Lowering new filter

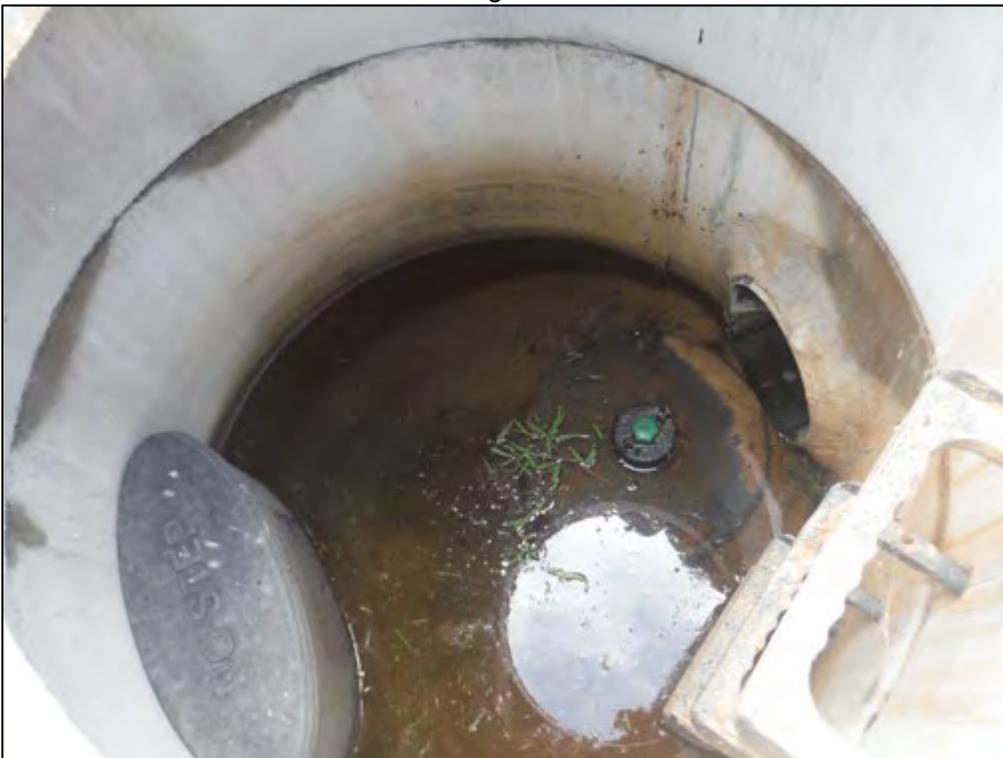
BMP #23: Howard Hall Quad II Courtyard (Contect Stormfilter 2)
Standing water

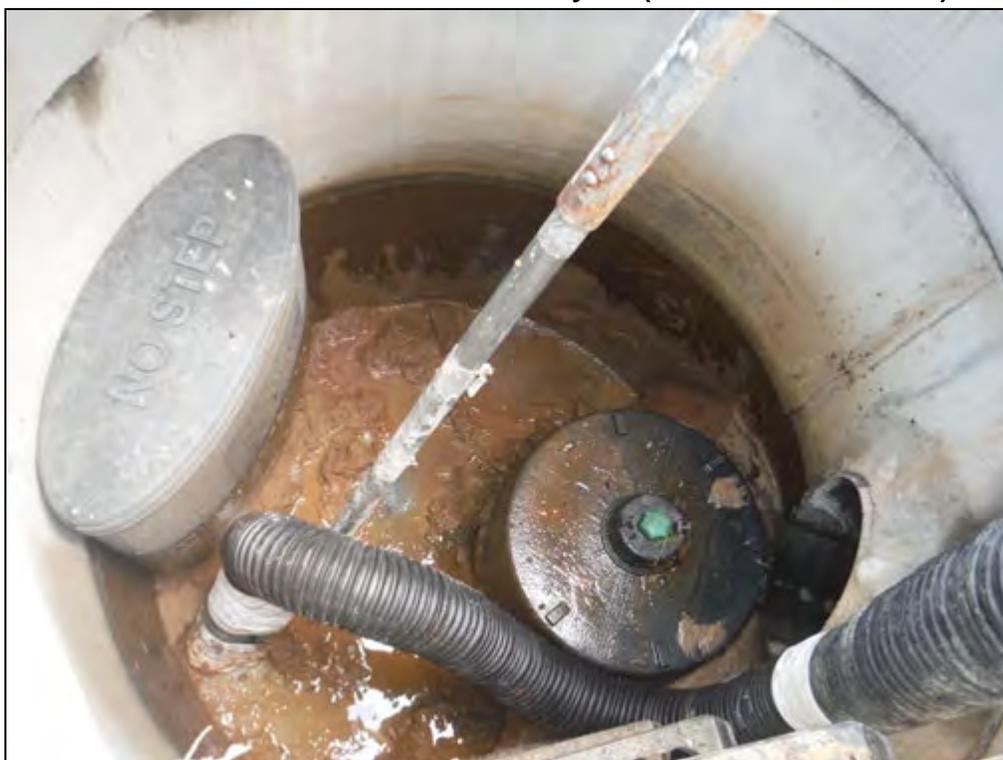
BMP #23: Howard Hall Quad II Courtyard (Contect Stormfilter 2)
Removing accumulated sediment
